## STATE HIGHWAY ADMINISTRATION

### Research Report

## DURABILITY ASSESSMENT OF PREFABRICATED BRIDGE ELEMENTS AND SYSTEMS

### PROJECT NUMBER SP309B4E FINAL REPORT

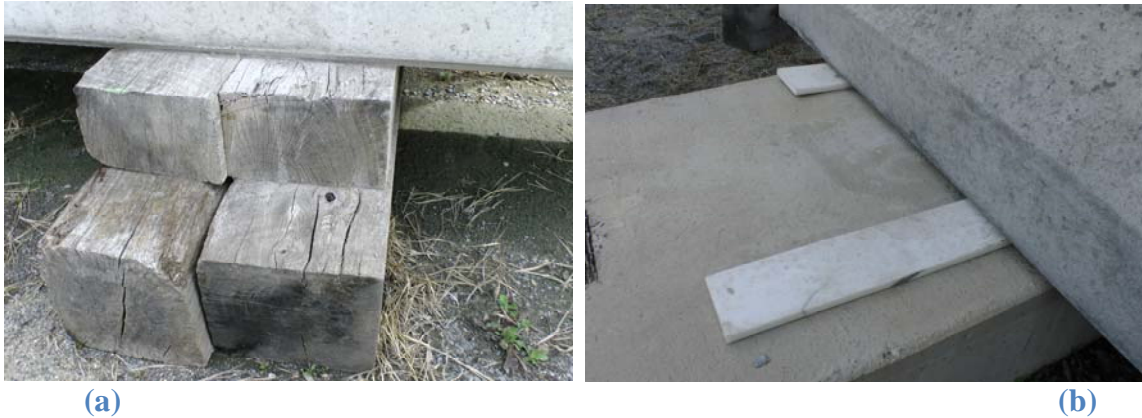
General notes were taken to show how beams were stored and stacked. Two different support conditions were noticed, both having almost same height ( $\pm 0.5$ -in.): the concrete pedestals had a neoprene pad running along the underside of the beams while the wood had none (Figure 2). It

was also observed that the neoprene pad could have been used to account for the differential height off the ground between the two supports and/or to prevent moisture ingress.

**Figure 2: (a) Beams stored on wood blocks and (b) concrete**

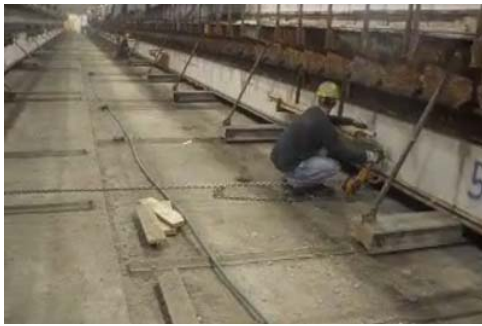
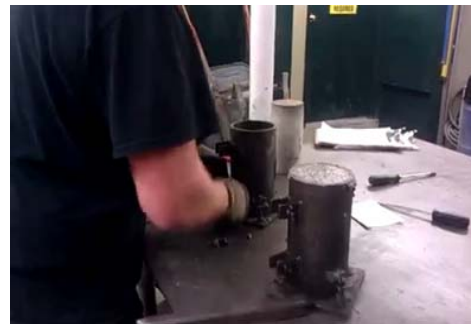
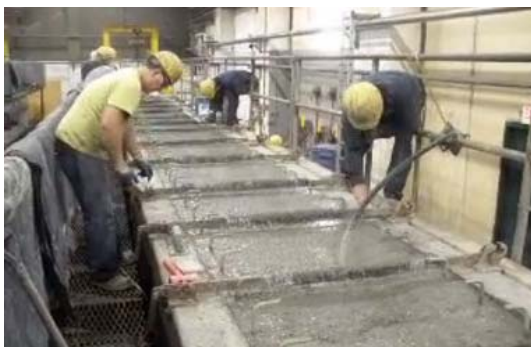
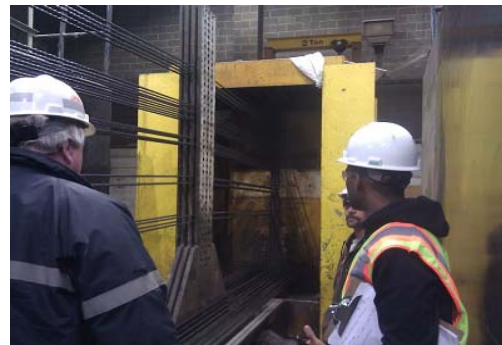
**Figure 6: (a) Formwork, (b) Concrete test, (c) Concrete Pour, and (d) Strand Inspection at NPP**

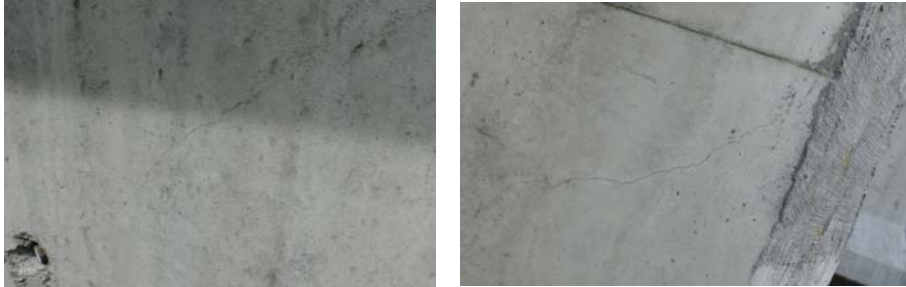
Condition assessment of the prestressed concrete I-girders' camber and crack widths (shown in Figure 7) is necessary to determine the level and appropriate repair technique or extent of suitability. The condition of the girders reveal their level of distress at the beam-end that unfortunately can get larger over time. The crack locations, widths, lengths and type, were noted (see Tables 2 and 3), utilizing the inspection data compiled during the plant investigation. Sixteen (16) prestressed concrete I-beams, stored at Northeast Prestressed Plant (NPP), ranging in age 3 months to 1 year were inspected.

Figure 7: Beam end cracks of prestressed concrete I-beams stored at NPP

- Thin, diagonal, hairline cracks were found in most of the beams, notably at the ends of the beam and could have been as a result of the prestressing steel release and concrete curing process. It is believed these will not affect the structural integrity of the beams but should be noted.

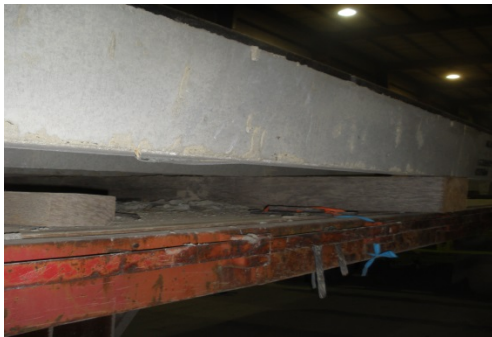
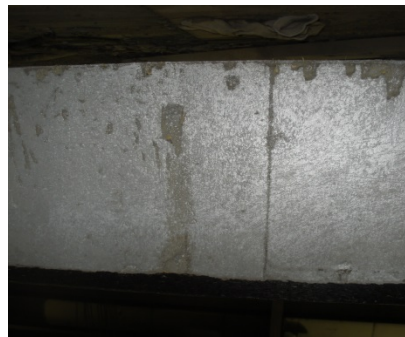
The photos, shown in Figures 8 and 9, reveal the surface finish of the beams with some small cracks and spalls. This documentation indicates the condition of the beams before being transported to the storage area.

**Figure 8: Finished prestressed beams with some (a) spalling and (b) small cracks**

- The major spalling phenomenon was not noticed in the beams except for little ingress, which has no structural implications and could be easily patched.

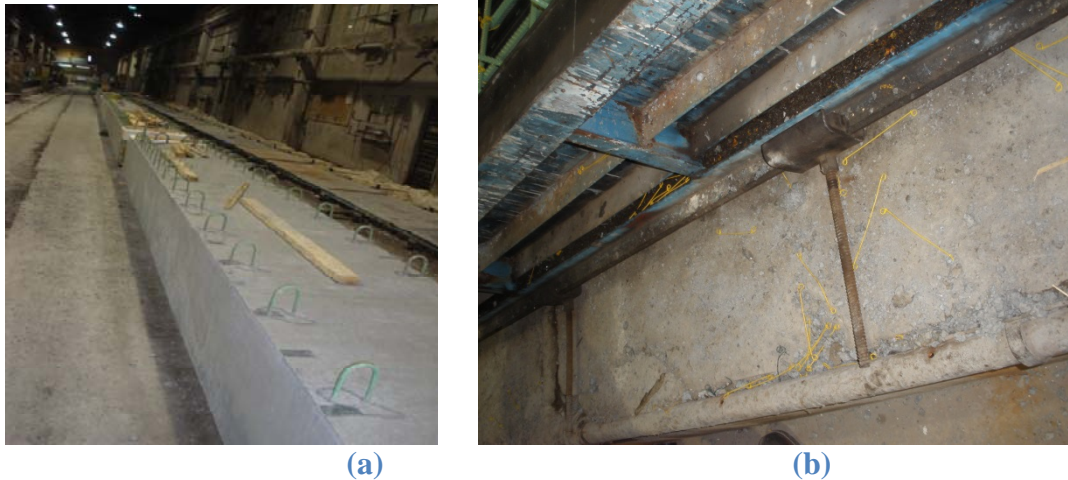
**Figure 9: Finished prestressed beams with some (a) hairline cracks and (b) spalling**

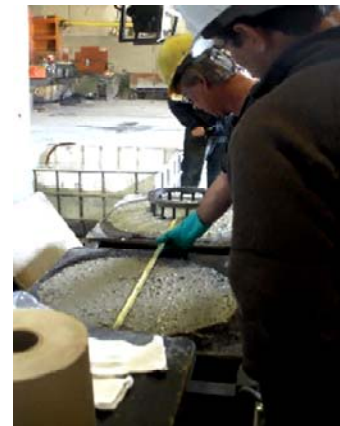
Prior to pouring the concrete into the molds, concrete tests (ring, slump and air) were carried out to ensure the concrete met the required consistency and design (Figure 10). The concrete passed the design specifications and PCI standard. Although the external surface showed rust and lack of cleanliness, the formwork was well placed on a hard base/support. The inside of the formwork, in which the concrete was to be placed, was smooth and aligned horizontally. It was noted that Northeast Prestressed Products (NPP) had a dedicated area for concrete evaluation, which promoted organization and space for testing. This type of dedicated area was lacking at Newcrete Products and was reflected in the lean indices score shown in Table 1.

**Figure 10: Concrete evaluation**
